Report No. CETHA-BC-CR-89352

## Task Order 2 Enhanced Preliminary Assessment

FORT DES MOINES  
DES MOINES, IOWA

December 1989

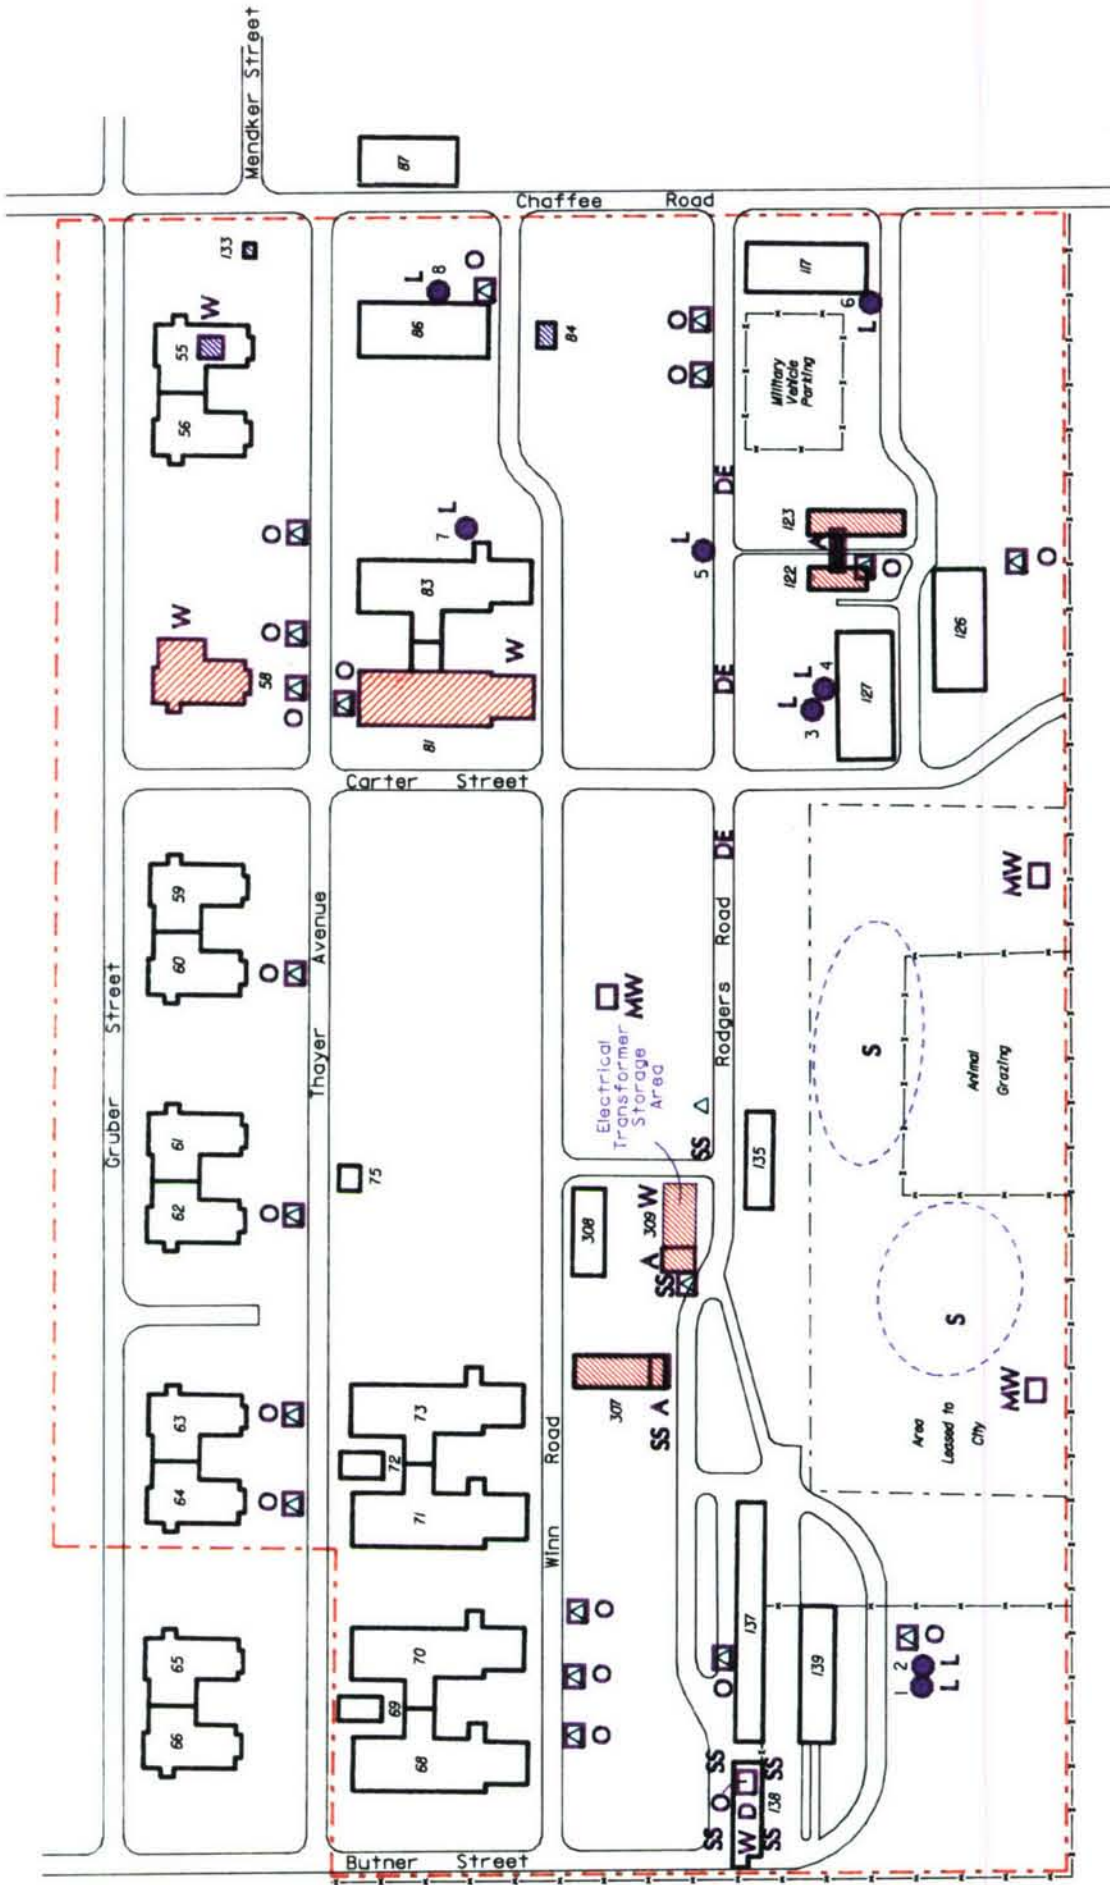
Figure ES-1  
Property Information  
Composite

- Underground Storage Tank
- Transformer
- Chemical Storage
- Building With Asbestos-containing Material
- Building D8 With Pesticide Contamination and Potentially PCB Laden Elevator Shaft Oil
- Former Firing Range
- Open Dump

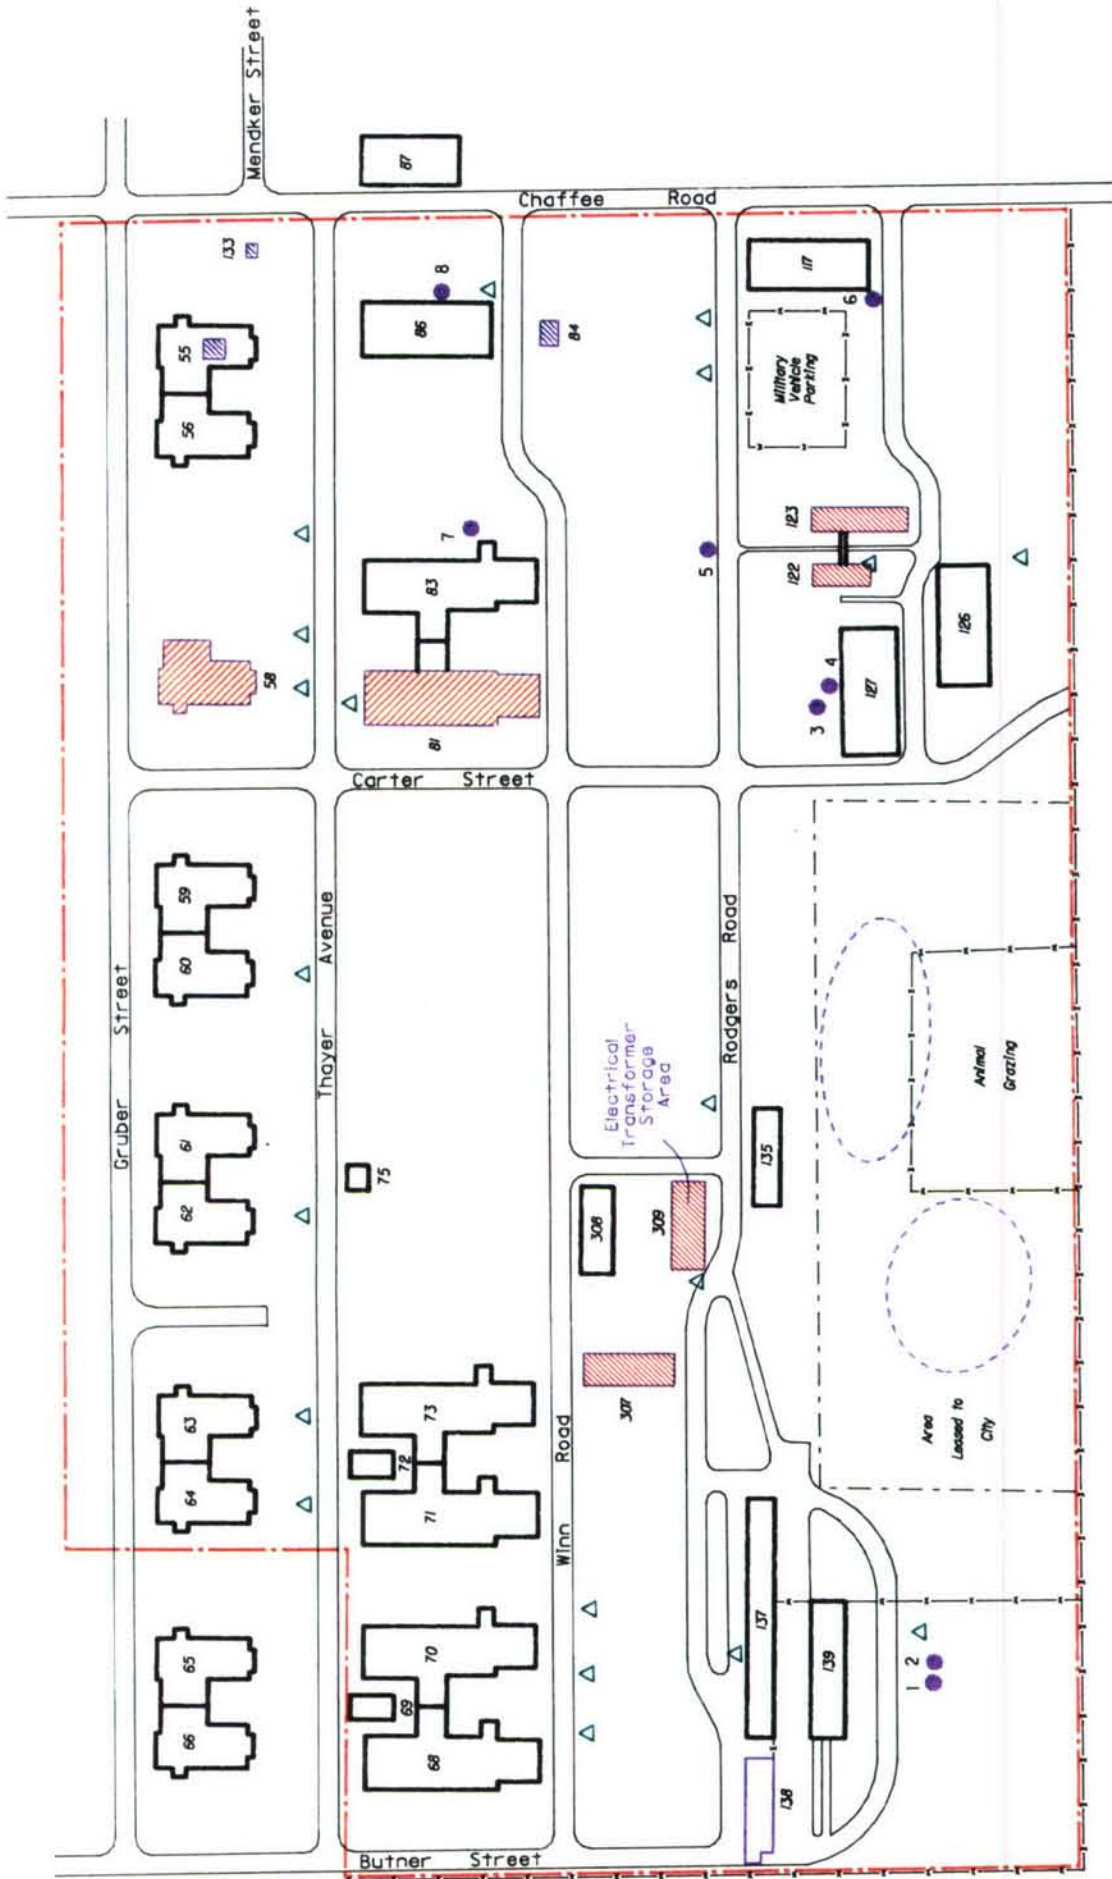
- ENVIRONMENTALLY SIGNIFICANT OPERATIONS
- Underground Storage Tank
  - Transformer
  - Chemical Storage
  - Building 138 with Asbestos-containing Material
  - Building 138 with Pesticide Contamination and Potentially PCB Laden Elevator Shaft Oil
  - Former Firing Range
  - Open Dump
